(Post-construction)

Envelope Leakage Test

Project ID: 25-0305 - Robert Morrison - 358

Address: 356 High St

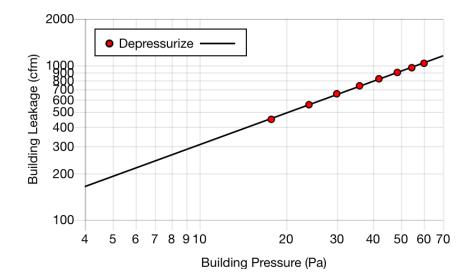
<u>Target (Pa)</u> Baseline	<u>Bldg (Pa</u>) -1.1	Adj Bldg (Pa)	Fan (Pa)	Flow (cfm)	<u>Config</u>
-60.0	-61.1	-60.1	-34.6	1,070.0	Ring A
-54.0	-55.5	-54.5	-30.2	1,001.8	Ring A
-48.0	-49.5	-48.5	-26.2	933.6	Ring A
-42.0	-42.9	-41.9	-205.5	849.1	Ring B
-36.0	-36.9	-35.9	-166.5	765.0	Ring B
-30.0	-30.9	-29.9	-131.0	679.2	Ring B
-24.0	-25.0	-24.0	-94.3	577.2	Ring B
-18.0	-18.7	-17.7	-60.7	464.0	Ring B
Baseline	-0.9

Test Conditions: Volume includes crawlspace and attic. Tested both units at once from mechanical access area which at this time of the test was well connected to both units. Interior doors open, windows closed and locked. ERV and plumbing traps taped off, except for one sink which we missed.

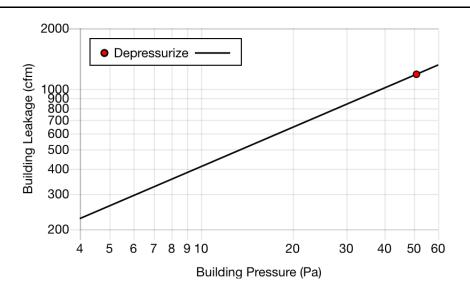
Test Conditions: Tested house as-is. Volume includes crawlspace. Tested both units at once with all interior doors open. Nothing taped off.
